FIGHT AGAINST THE NATURE - ŽILINA TUNNEL

Abstract

The twin two-lane highway Tunnel Žilina was planned to be mined using the NATM principles. The encountered ground turned out to be highly compressible, and cohesionless at the same time. The planned initial support measures, could not find an effective control over the tunnel excavation. The supports could not reduce the lining large vertical settlements of up to 200 mm, and could not stabilize the cohesionless ground pouring from the tunnel face. At higher overburden the lining deformation was successfully kept within the safe limits by building the top heading temporary invert, and by installing the tunnel invert at a short distance from the face. Although the total lining settlements remained relatively high, the balanced support of the two inverts allowed controlling the speed of the lining deformation development. Finding a reliable solution for stabilizing the face became determinant for the tunnel completion. The solution was a compensation grouting of 20 bar which increased the ground stiffness by increasing the ground confinement. However, the successful support measures led to a slower advance. Several trials were perfor

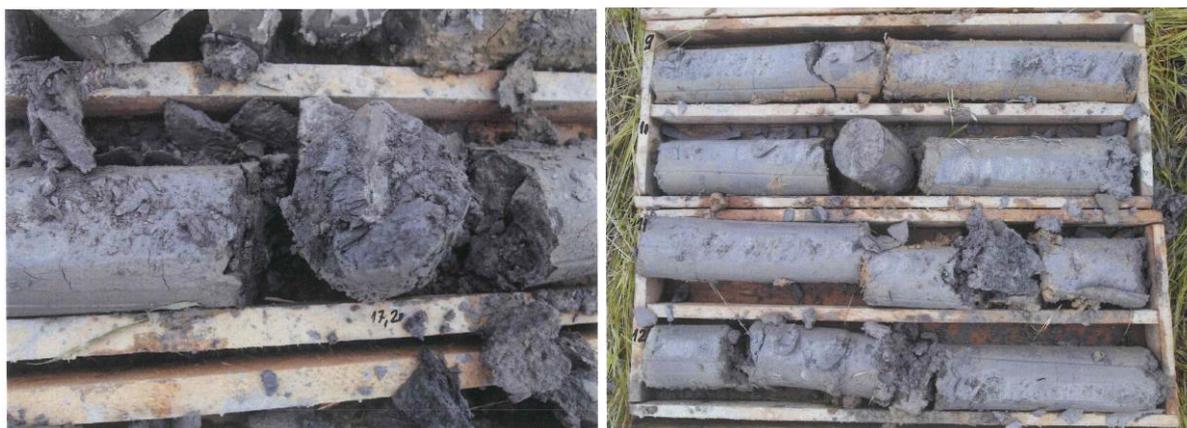
Weathering reached to depths of about 10 m below the bedrock surface. Influence of weathering was more pronounced in the tectonic zones, which contained small fragments of claystone rock embedded in clayey matrix, Fig. 1.

Fig. 1 Cores of weathered claystone

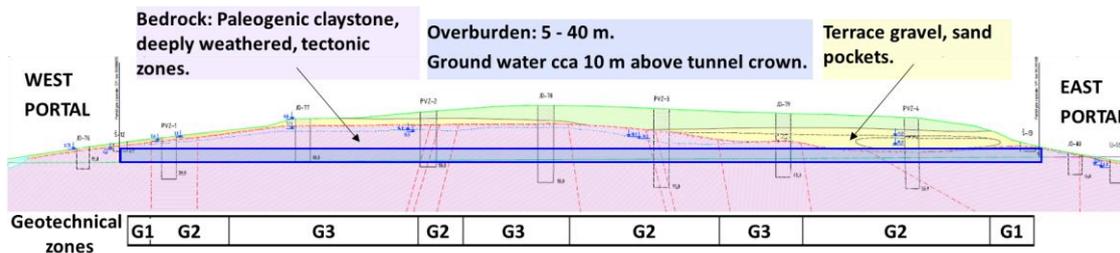
The depth of the tunnel crown ranged from 5 to 40 m, Fig. 2.

Fig. 2 Geological profile with expected geotechnical zones

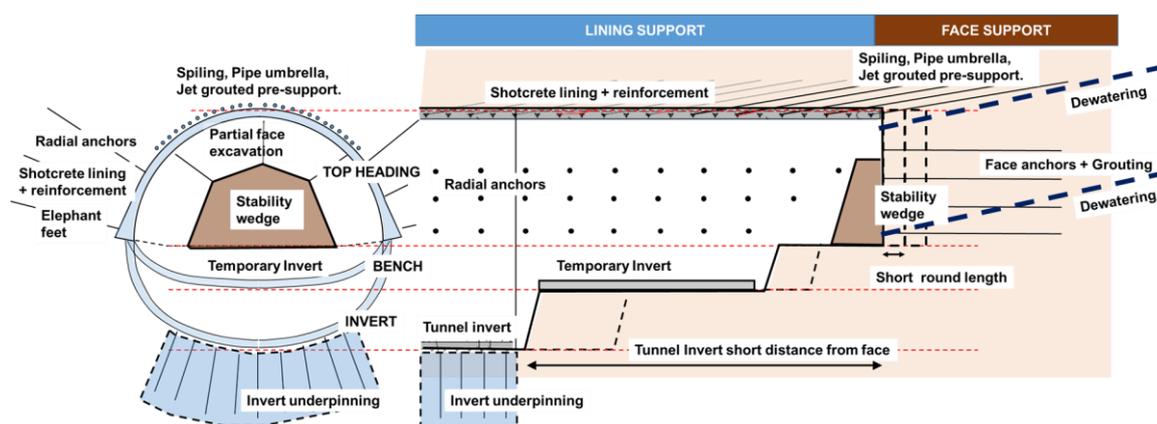
On the other hand, the tunnel design was prepared for the ground behavior, including the weak ground with short standup time, and soft ground providing minimum passive support to the lining. There were seven tunneling classes planned in tender documents, and in the bid documents, which included a complete range of soft ground support measures, Fig. 3: short excavation round, circular shape of shotcrete lining, tunnel invert, top heading temporary invert, elephant feet, radial bolts, face ground wedge, partial face excavation with immediate shotcrete stabilization, face anchors, spiles canopy, grouted IBO umbrellas, grouted pipe umbrella, dewatering boreholes, chemical permeation grouting (East portal).

Fig. 3 Conventional soft ground support measures

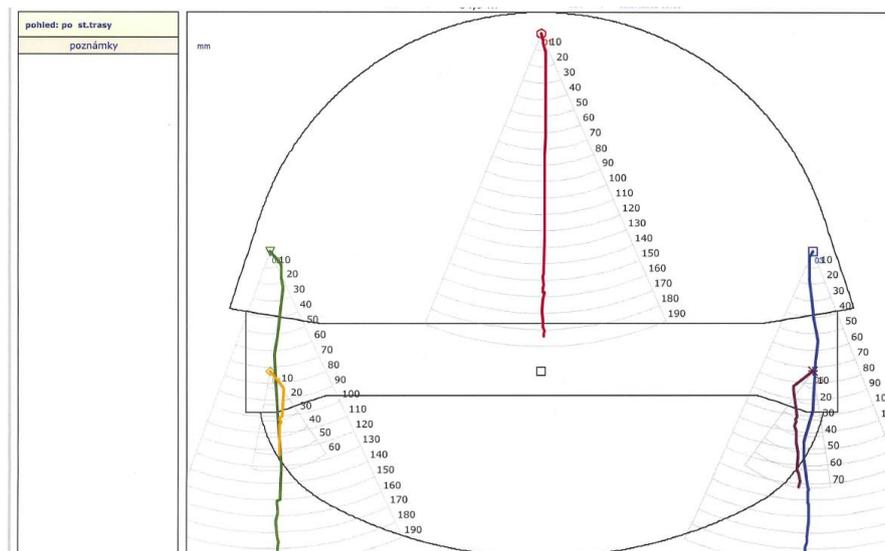
The ground high compressibility was demonstrated by the substantial vertical lining settlements ranging from 120 mm to 200 mm. The top heading lining footings were being punched into the compressible ground, Fig. 4.

Fig. 4 Vertical lining settlements up to 200 mm.

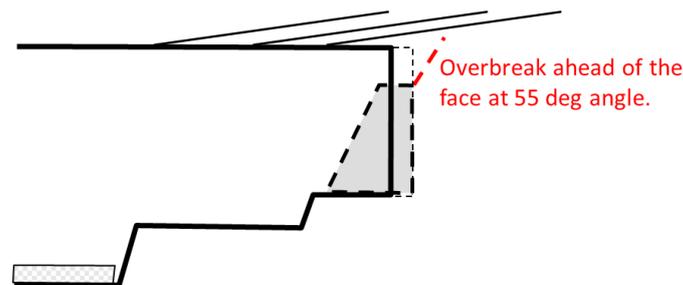
The overbreaks were increasing the length of the excavation advance round, and thus exposing the umbrellas for a longer length, Fig. 5. As a result the umbrella pipes were overloaded, and bended, which allowed the ground loosening above the umbrella. The loosened ground was pouring between the umbrella pipes. That cohesionless ground behavior presented a continuous threat to the excavation, and led to two sinkholes.

Fig. 5 Overbreak at the face perimeter increasing the advance round

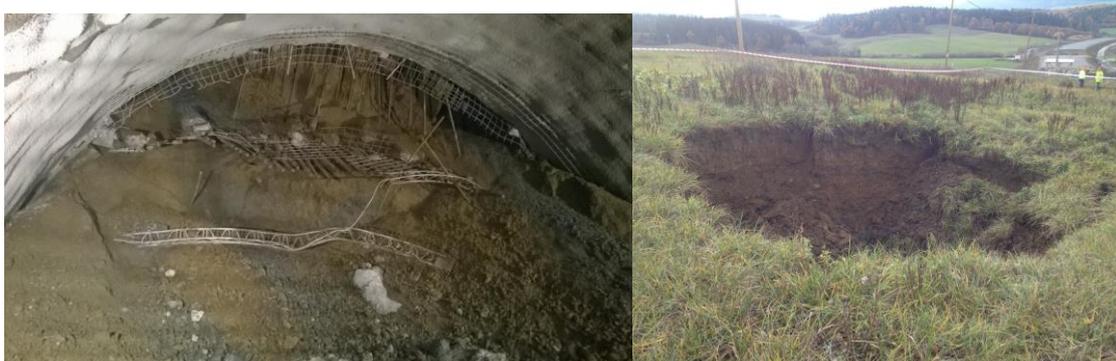
The two sinkholes were caused by the face instability. First the overbreaks at the top of the face exposed the umbrellas for a larger length than specified, and the cohesionless ground started pouring down between the pipes, which had a relatively small spacing of 100-200 mm. The pouring went for hours, and could not be stopped by the shotcrete. At the end the overbreak reached the quaternary sediments, and a crater propagated to the surface. Rapid inflow of material into the tunnel eventually broke the umbrella, Fig. 6.

Fig. 6 Inflow of Quaternary sediments in the tunnel after sinkhole formation

The two sinkhole events demonstrated the localized nature of the collapse. The collapsed ground went through a small hole in the tunnel, while the ground stabilization wedge at the face, and the shotcrete lining remained stable and unaffected.

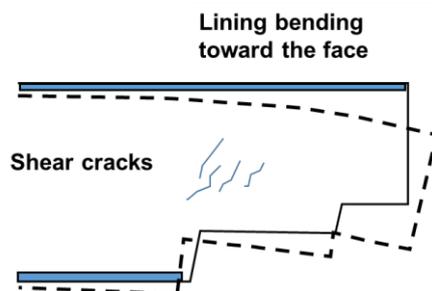
The lining vertical settlements, when displayed in the longitudinal profile, showed that the lining was bending towards the face. In response to every new excavation round the largest settlement increments were measured close to the face, and were diminished with increased distance from the face. The top heading lining behaved like a cantilever fixed at the tunnel invert section with a free end bending down towards the tunnel face. The longitudinal lining bending generated shear cracks. The shear cracks were not considered hazardous for the lining

Fig. 7 Large settlement increments at the face, and lining bending

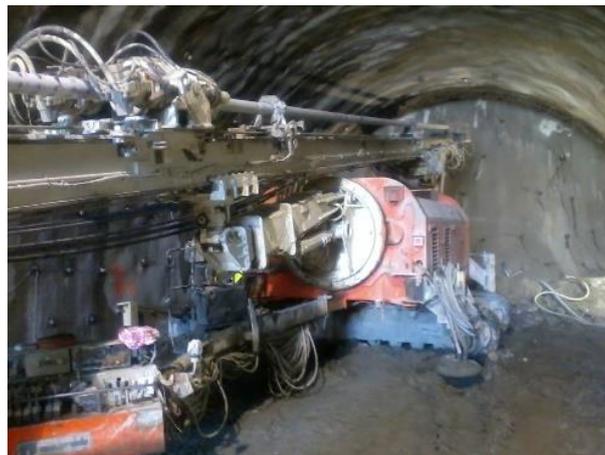
In an attempt to improve the anchors effectiveness the drilled anchor diameter was increased from 70 mm to 170 mm. The drilling was performed by Cassagrande machine using the cement flushing to minimize the ground disturbance, Fig. 8. The large diameter anchors filled with the cement grout had an effect like the method of ground replacement, however, in the end the number of 90 bolts in the face was not sufficient to prevent overbreaks which became more frequent at higher overburden of more than 20 m.

Fig. 8 Drilling of 170 mm diameter face anchors by Cassagrande machine

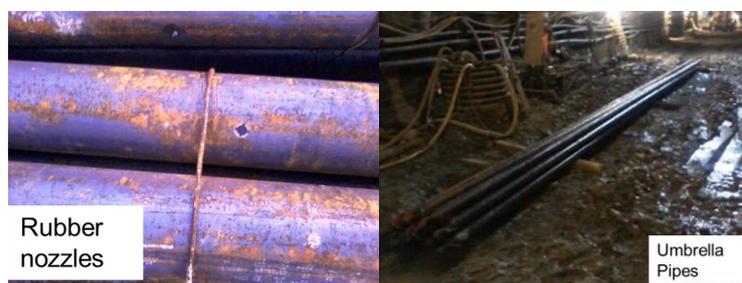
The umbrella pipes of I.D. 114 mm were installed in one piece by the Cassagrande machine using the cement flushing. The pipe was grouted all at once along the full length. For that purpose the pipes were fitted with rubber nozzles at a distance of 0.5 m, Fig. 9.

Fig. 9 Umbrella pipes of 12 m / 114 mm with grouting nozzles

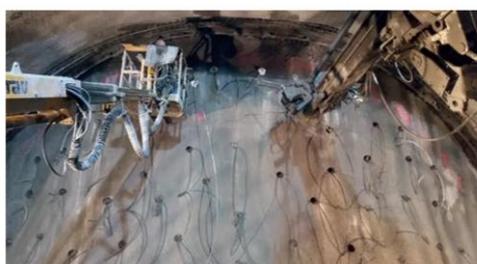
The compensation grouting of the face was performed through perforated manchette pipes. Packers were used for stepwise grouting of 1 m pipe sections, Fig. 10.

Fig. 10 Compensation grouting of the face

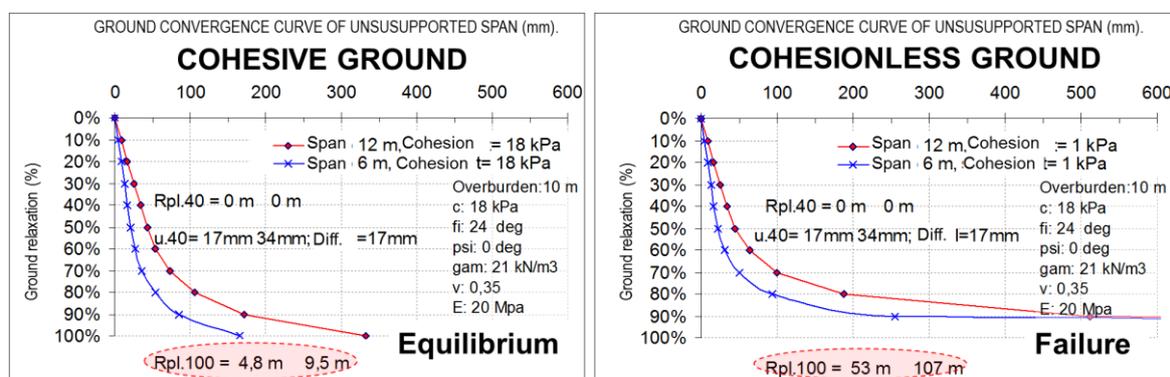
Excavation of the small galleries did not guarantee that it would prevent the cohesionless ground pouring, and overbreaks formation at the face. The weak and cohesionless ground behavior had stronger impact on the tunnel behavior than the positive effect of a smaller tunnel face. A simple Ground Convergence Curve analysis demonstrated that the size of the excavation opening of 6 m or 12 m had no influence on the convergence curve of the tunnel in cohesionless ground, Fig. 11.

Fig. 11 Ground convergence curves demonstrating the dominant impact of the cohesionless ground compared to impact of the tunnel span
