# Tunnel

ČASOPIS ČESKÉHO TUNELÁŘSKÉHO KOMITÉTU  
A SLOVENSKÉ TUNELÁŘSKÉ ASOCIÁCIE ITA/AITES  
PODZEMNÍ STAVBY (VÝVOJ, VÝZKUM, PROJEKTOVÁNÍ, REALIZACE)

*MAGAZINE OF THE CZECH TUNNELLING COMMITTEE  
AND SLOVAK TUNNELLING ASSOCIATION ITA/AITES  
UNDERGROUND CONSTRUCTIONS (DEVELOPMENT, RESEARCH, DESIGN, REALISATION)*

## INTERACTION BETWEEN FOUNDATIONS OF THE TRAM BRIDGE AND THE SEWER „Q“ STRUCTURE IN PRAGUE

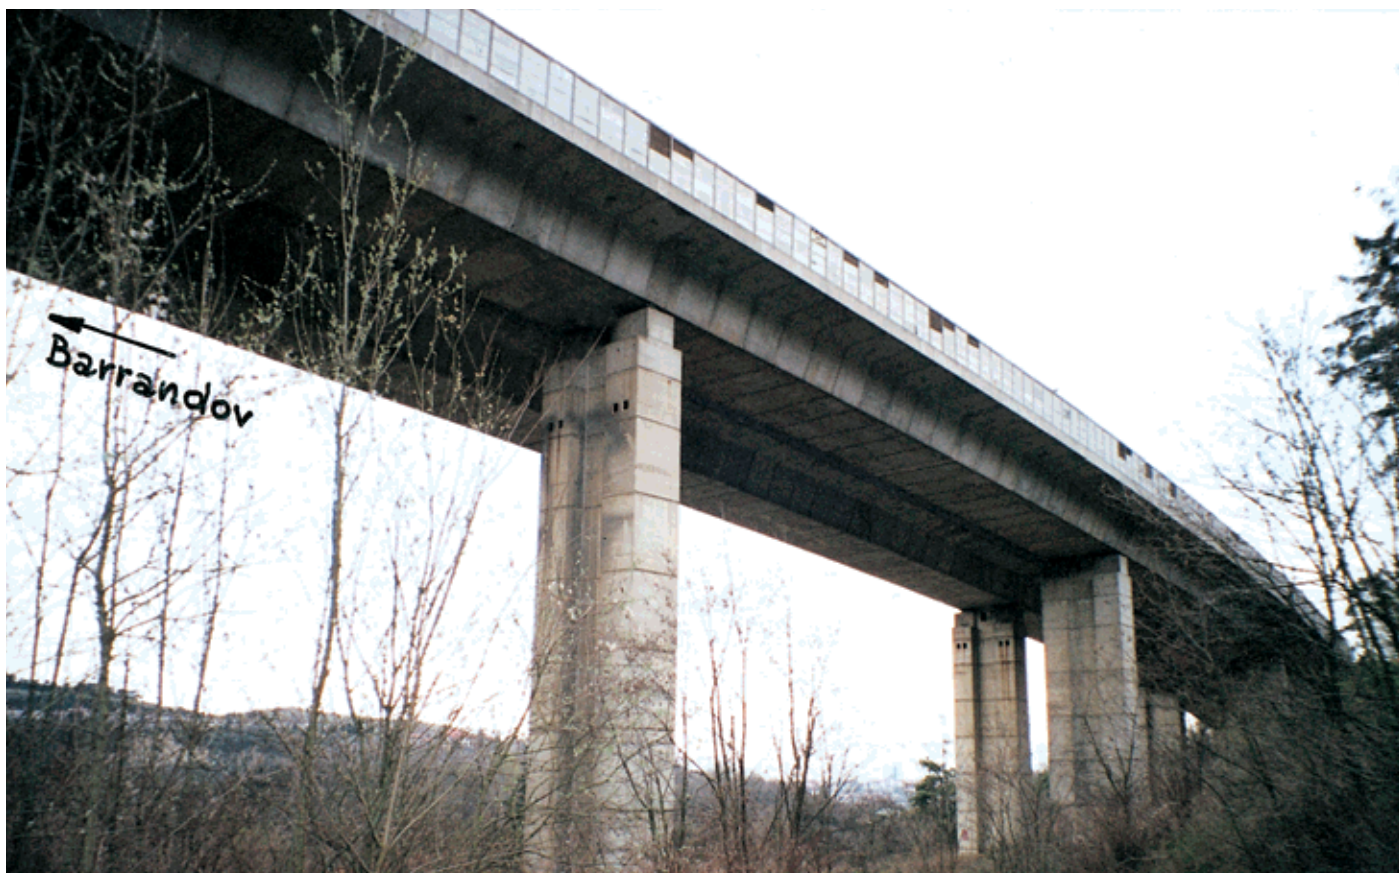
Obr. 3a,b Fig. 3a,b  
Silniční most přes Růžičkovu rokli  
Road bridge over Růžicka valley

To improve the situation of mass transport to the area of Barrandov housing estate, there has been designed an extension of the tram-line from Hlubočepy (the present-day final station) to Barrandov. The realization of this tram-line will be important even from the ecological point of view, because the existing mass transport from the housing estate and its neighborhood depends exclusively upon the bus transport, which cannot be considered as too „friendly“ with respect to protecting and forming environmental conditions, particularly among protected natural creations of Barrand Rocks and Prokop Valley (Fig.1). The new tram-line will be situated parallelly and just alongside the Barrandov radial road (Fig. 2), so that - with respect to the same terrain morphology - it will be in fact of the same character from the constructional point of view. It means that it will be needed to build up two bridges along the lower part of the Prokop Brook, the longer of which (for orientation: the upper one) passes through the so called Růžička Gorge in the height being locally more than 30 m (Figs. 3a, b).

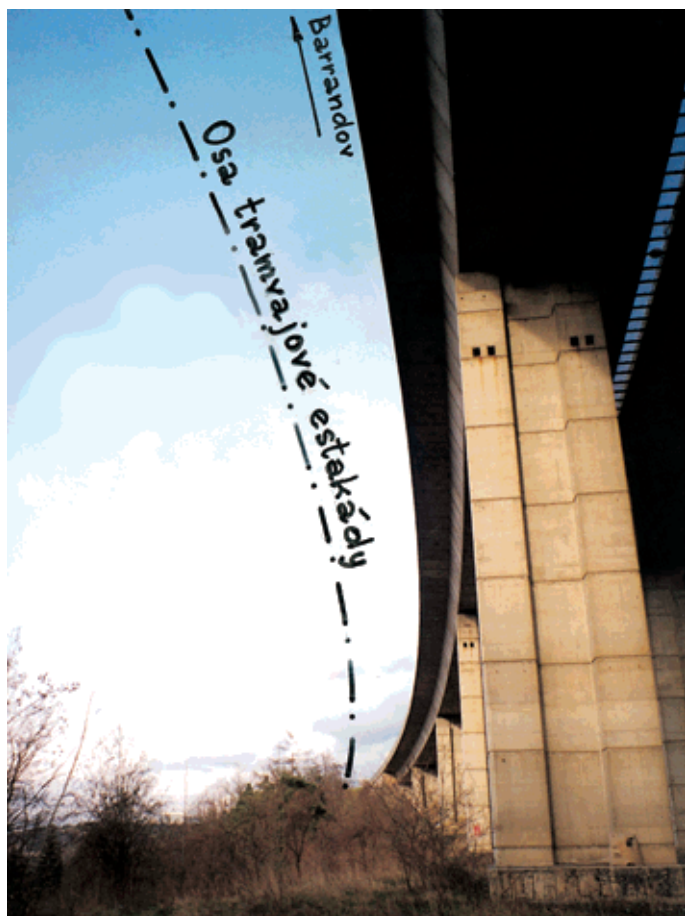
Obr. 2 Fig. 2  
Poloha tramvajového mostu Hlubočepy-Barrandov  
Position of the Hlubočepy-Barrandov tram bridge

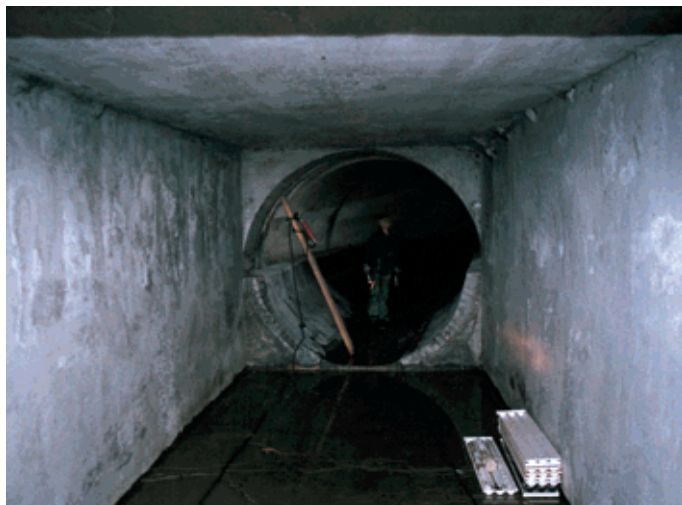
Obr. 8 Fig. 8

Monitoring ve stoce „Q“  
Monitoring in the sewer „Q“

Současný stavební stav stoky "Q" byl ověřován geofyzikálním průzkumem [2] v celé délce stoky od západní opěry horního mostu až k akumulacím nádrží dešťové vody (obr.8). Vyhodnocení měření pulsním georadarem stanovilo podél stoky anomální oblasti, v nichž se mohou nacházet za rubem ostění nevyplněné dutiny vzniklé při ražbě a vystrojování stoly, či oslabené zóny, které mohou být vázány i na původní stav horninového masívu (obr.9).

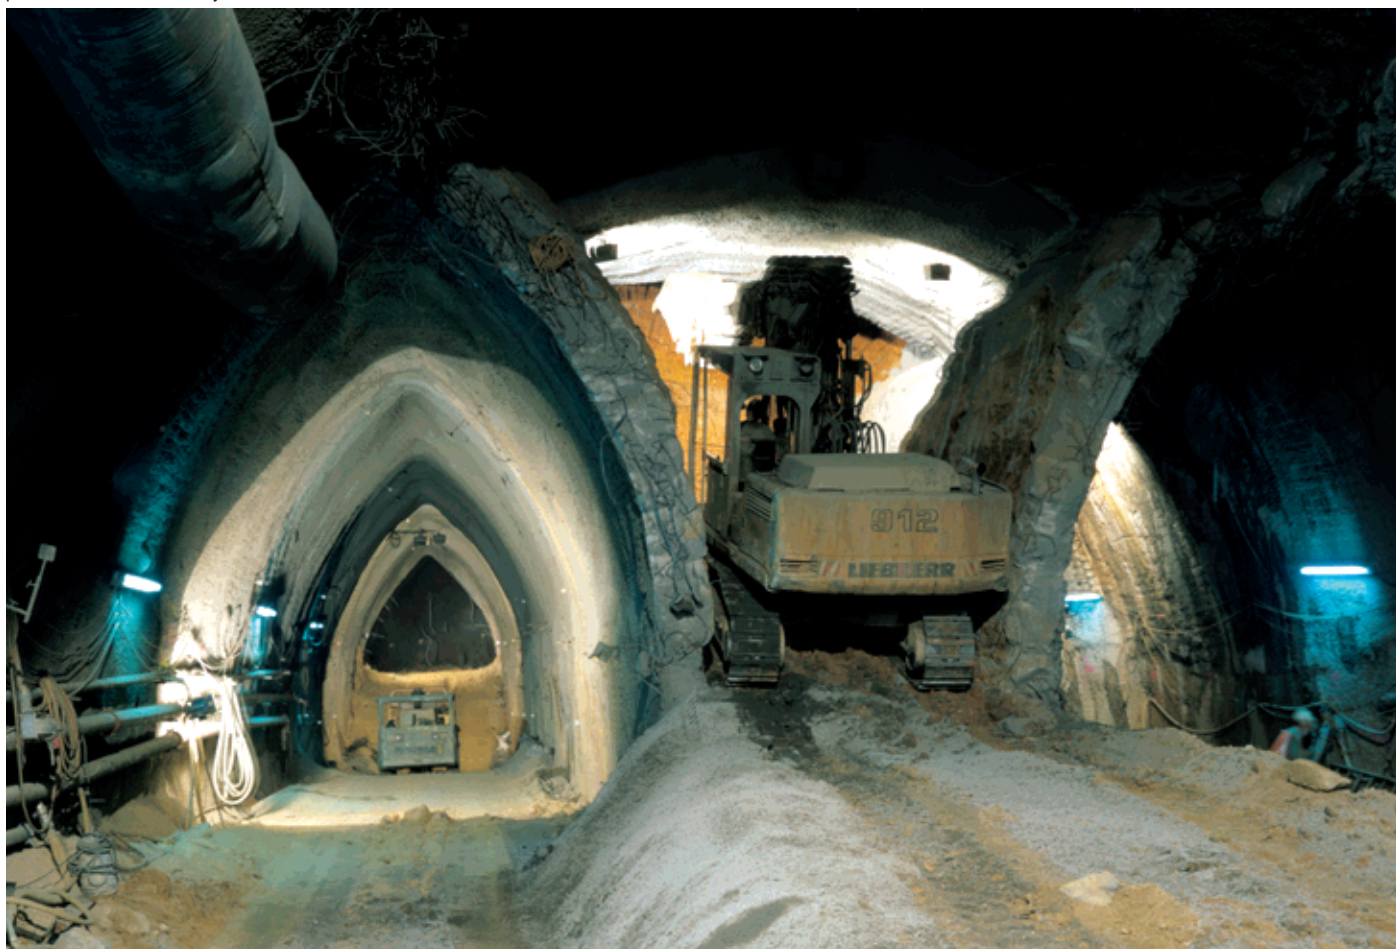
Obr. 4 Fig. 4  
Členění výrubu při NRTM  
Excavation sequence used at NATM

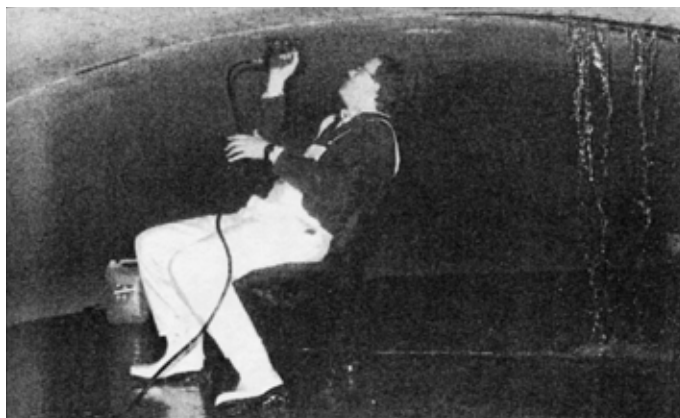
Obr. 2,3 Fig. 2,3  
Princip měření Impuls - echo - metodou  
Principle of measurement by the Impulse - Echo Method

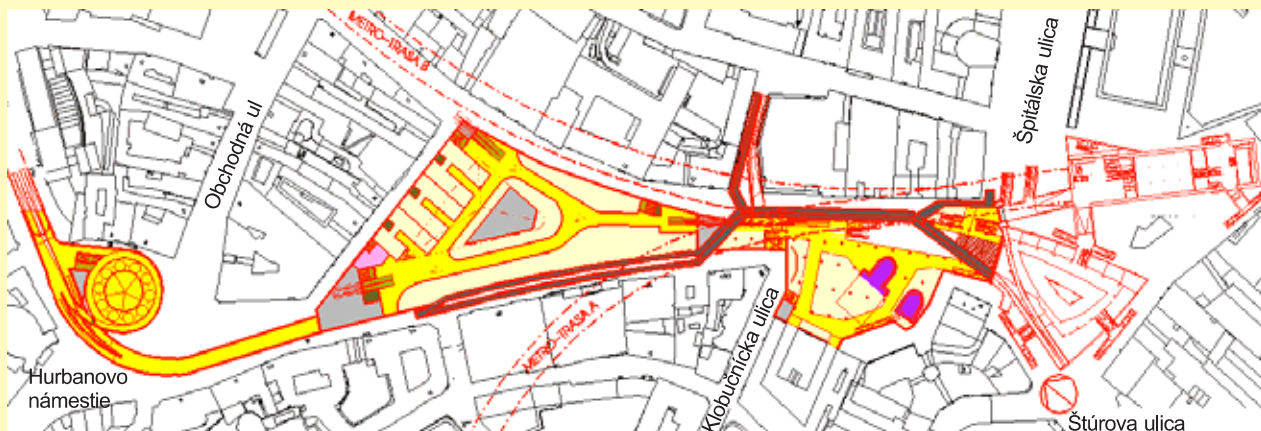
Obr. 2 Fig. 2  
Pôdorys prvého podzemného podlažia obchodného a parkovacieho centra  
Ground-plan of the first basement of the shopping centre and parking one

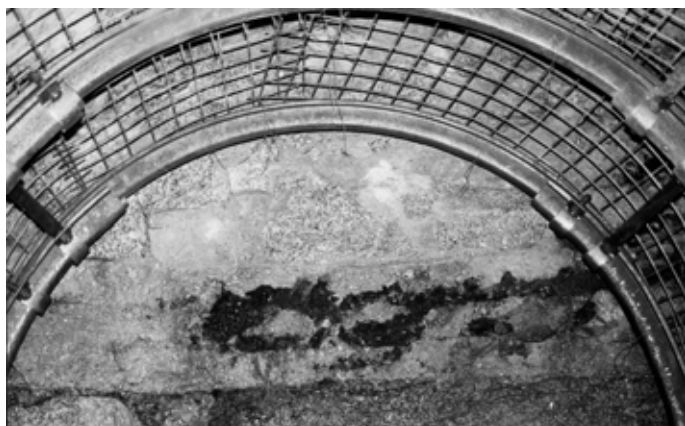
Obr. 4 Fig. 4

Čelba východní větve ražené štoly ve staničení 192,2 m. Ve vrcholu výrubu kamenné zdívo, pod ním „podkladní beton“, z části degradovaný, v dolní části zvětřalá žula. The face of the eastern branch of the driven gallery at chainage 192.2 m. Ashlar masonry is at the top heading, with partly degraded bedding concrete underneath, weathered granite is at the bottom part.

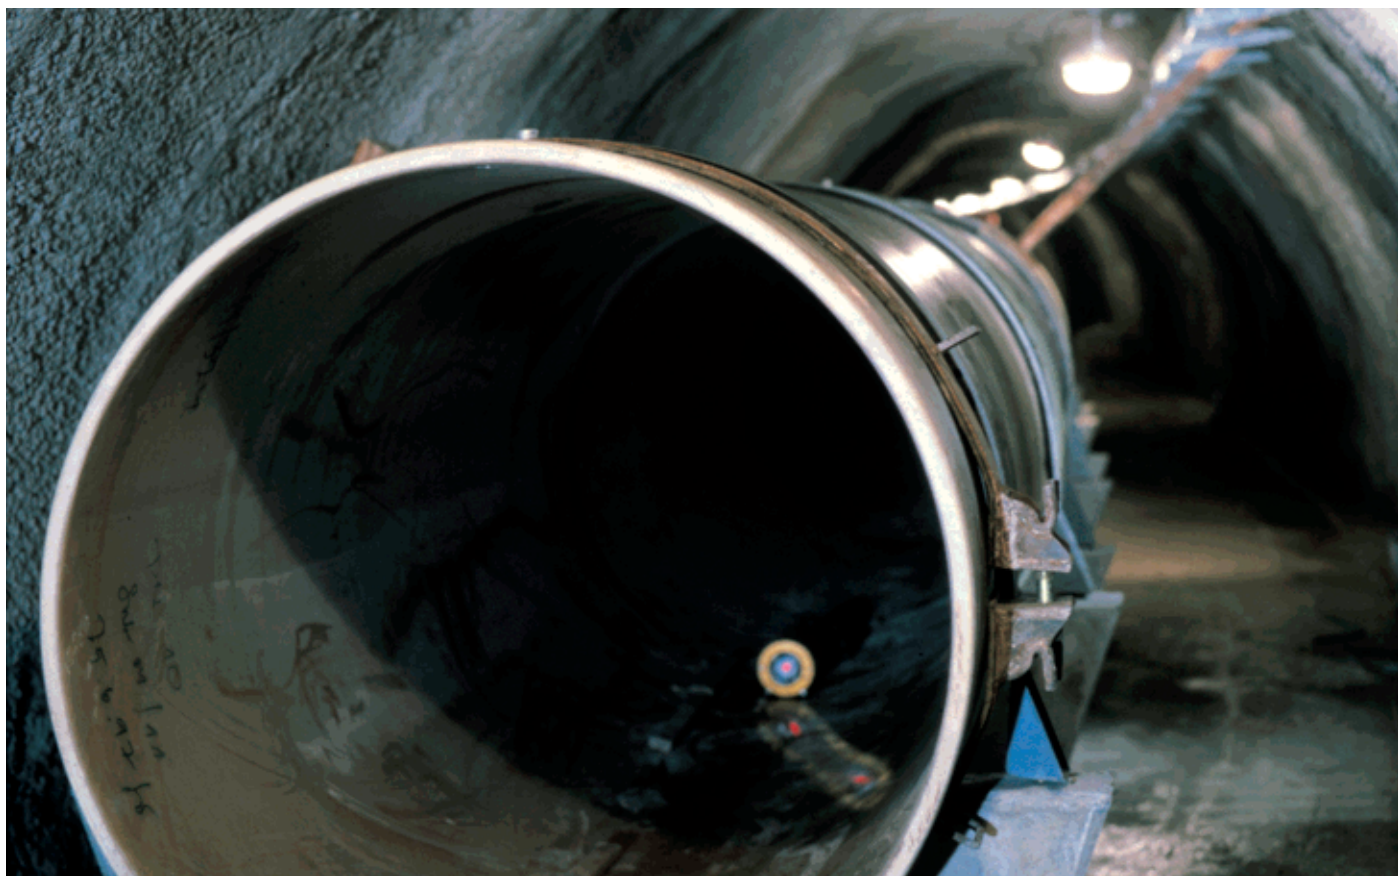
Obr. 5 Fig. 5 Štola Bystrc - Bosonohy - potrubí Hobas  
Tunnel Bystrc - Bosonohy - Hobas piping

Portal sections, always in lengths of 60 m were driven in the way of a classic technique and for the support there were applied steel armours of Dia 2120 x 16 mm with an internal cement lining. Said armours enable both to enter the tunnel because of inspection reasons and to connect the piped section of the conduit.

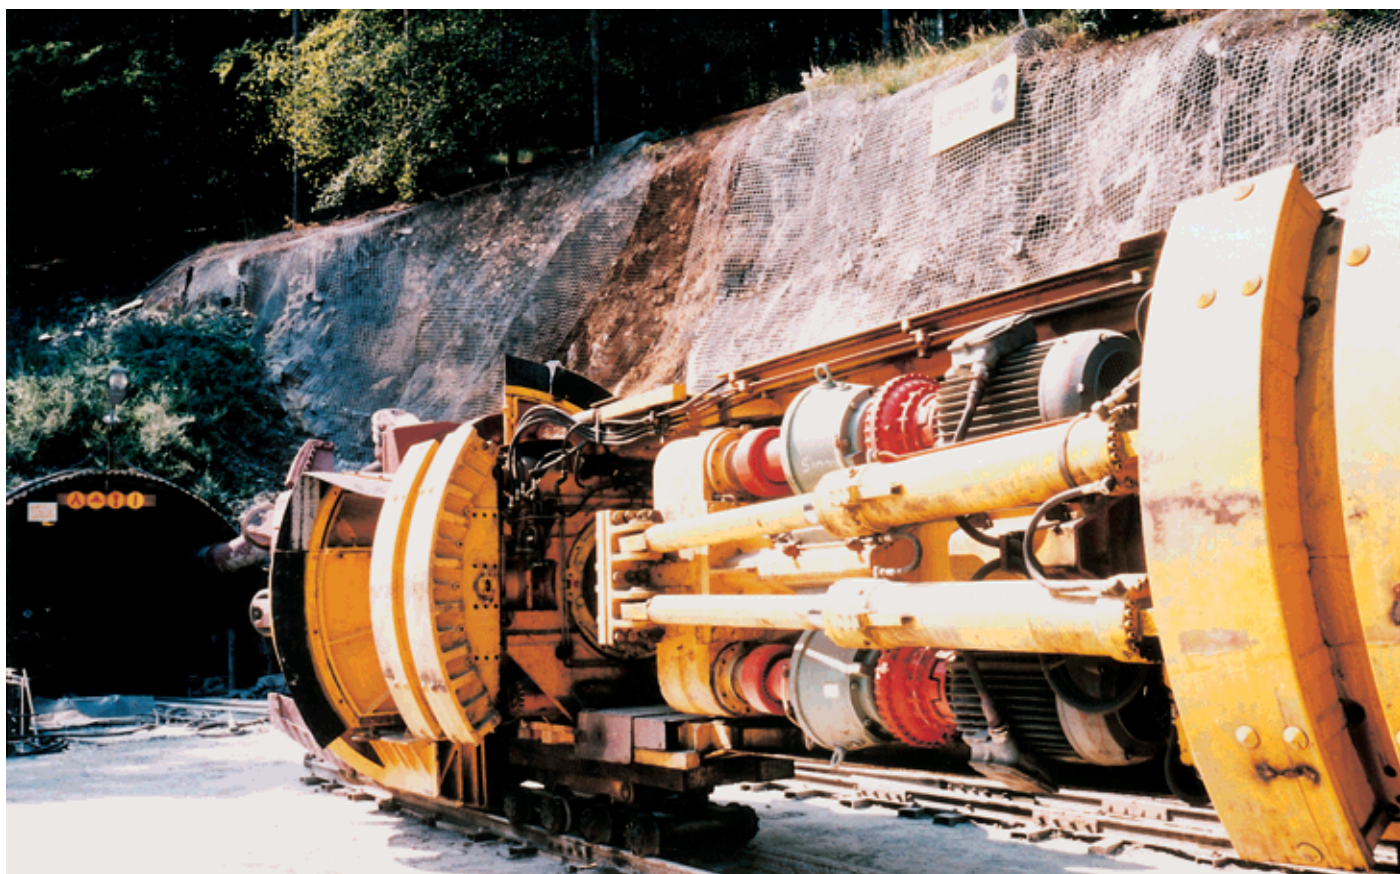
Obr. č. 6 Portál Bystrc - razicí stroj  
Bystrc portal - boring machine

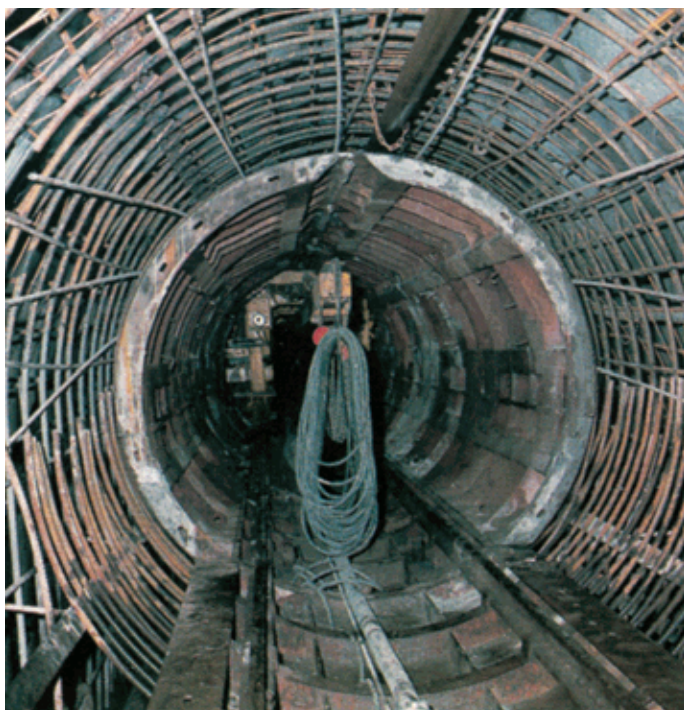
Obr. 7 Fig. 7  
Štola surové vody - betonáž  
Raw water tunnel - concreting

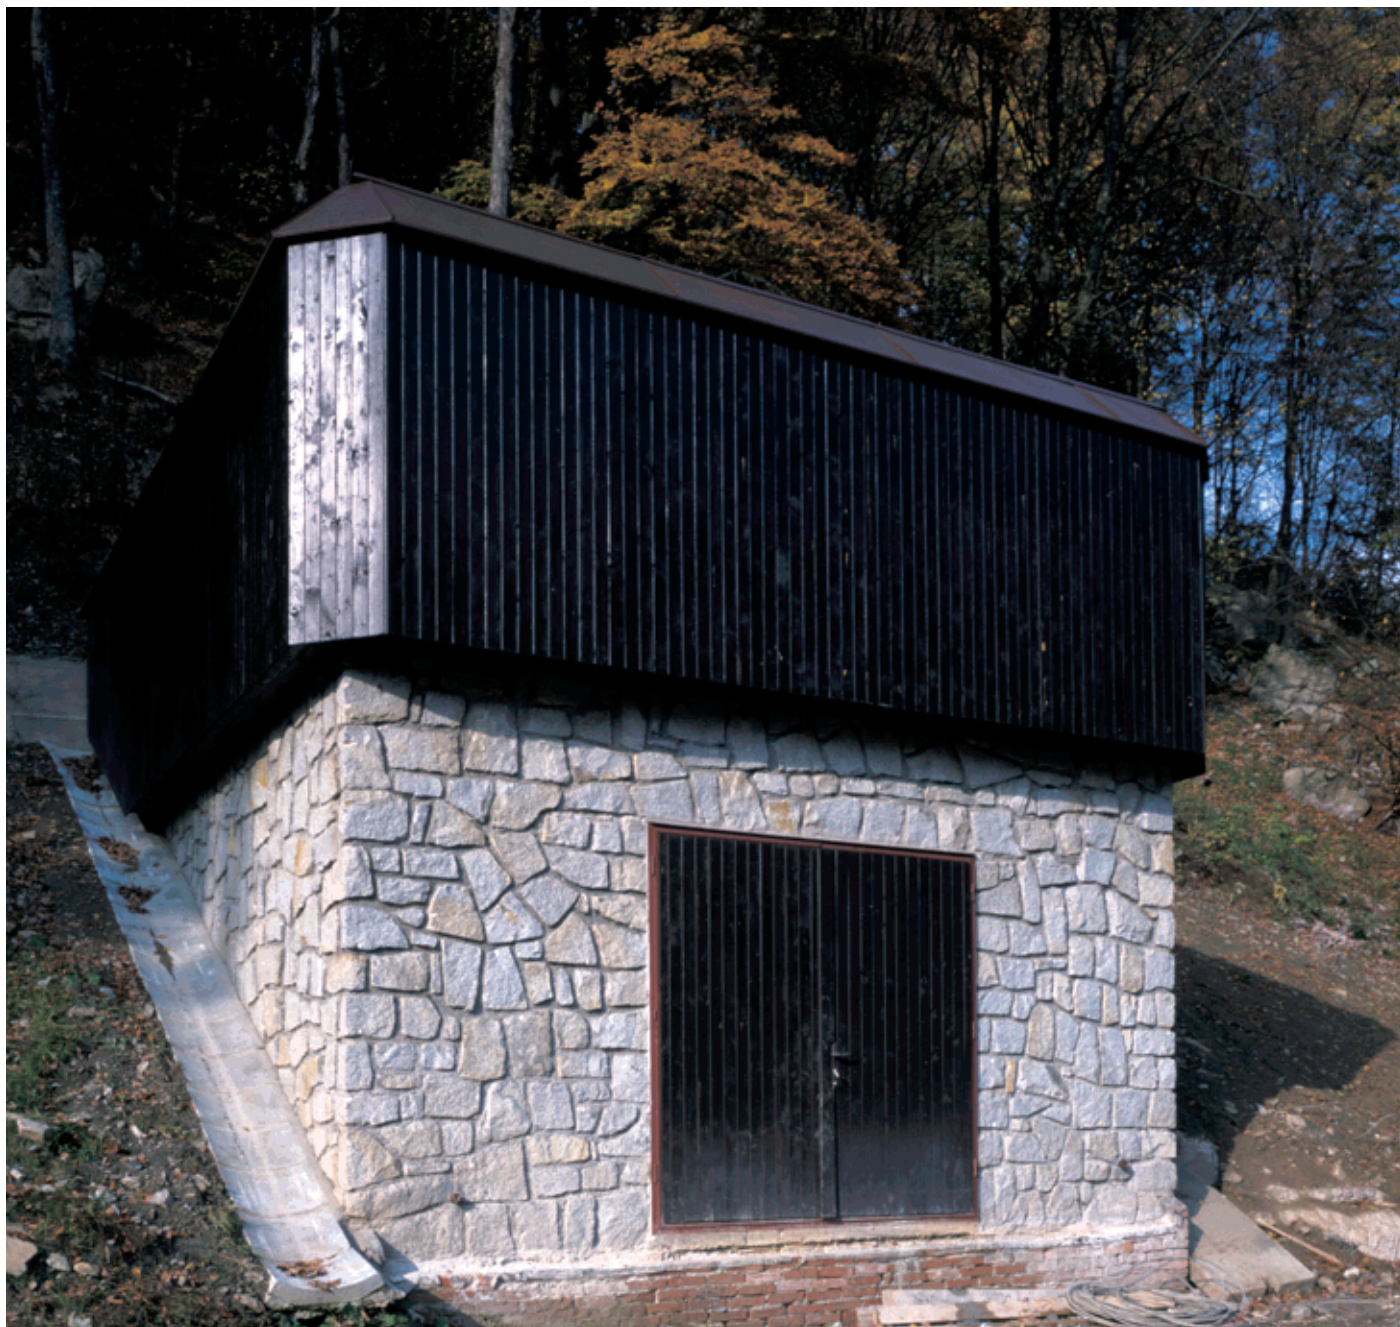
Obr. 8 Fig.8  
Portálový domek Bystrc  
Portal small house - Bystrc
